## HISTORIC AMERICAN BUILDINGS SURVEY

### 2022-2038 WEST LANVALE STREET (ROWHOUSES) (MIDTOWN EDMONDSON HISTORIC DISTRICT)

HABS No. MD-1442

Location: 2022-2038 West Lanvale Street, Baltimore, Maryland

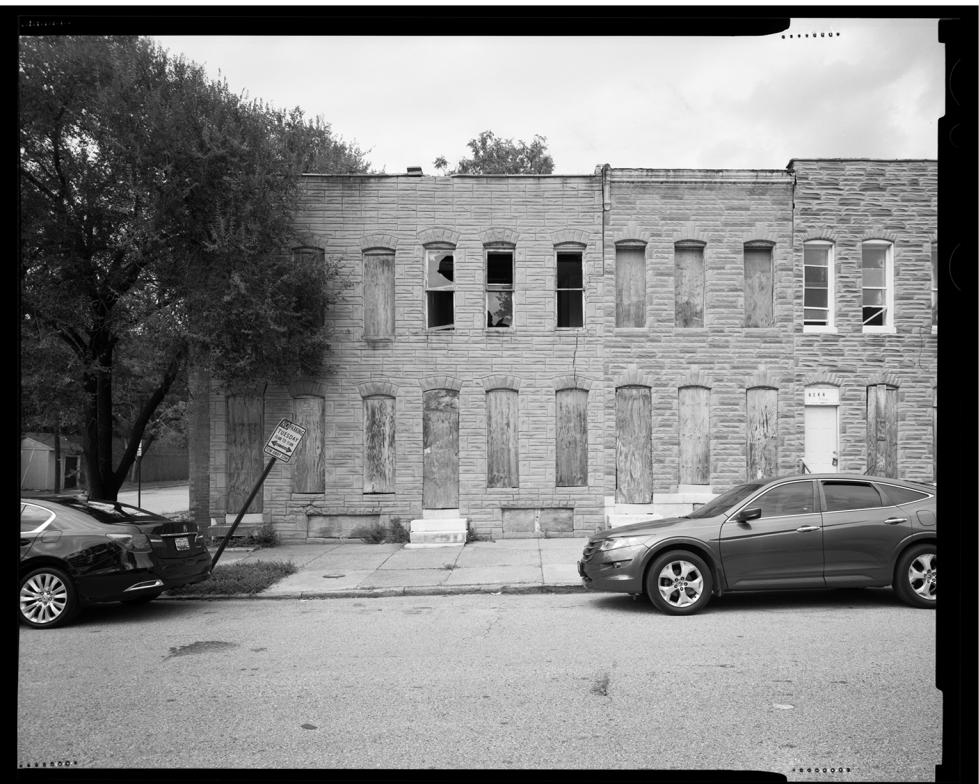
HABS No. MD-1442-1

| MD-1442-1 | View of façades of 2034-2038 West Lanvale Street, looking north. |

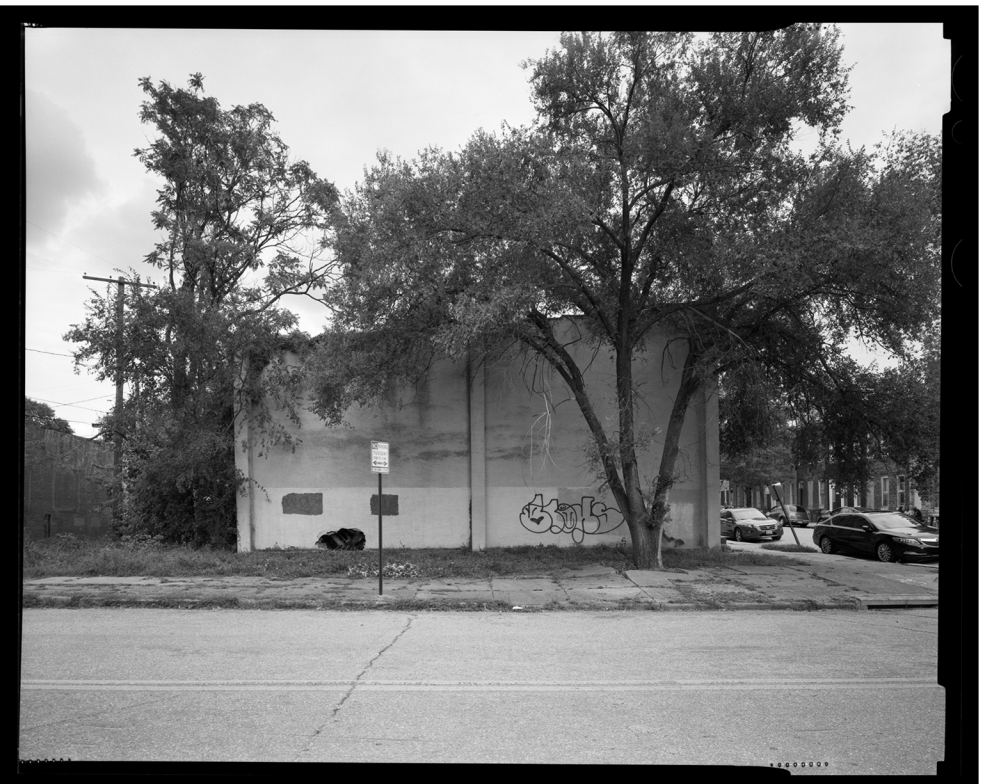
HABS No. MD-1442-2

| MD-1442-2 | View of side elevation of 2038 West Lanvale Street, looking east. |

All the rowhouses from 2022-2038 have small backyards that are entered from a common alley north of the properties. Although the north (rear) elevations of the rowhouses at 2028-2038 at the west end of the block are partially obscured by vegetation and the north wall of 2038 was in a state of total collapse at the time of the survey, it appears that most of these rowhouses had the same original features on their rear elevations: basement-level windows; a west side-hall-entry first-story door with transom accessed by steps; a single, first-story window on the east end; and a rear second-story three-sided wood-framed projection incorporating two second-story windows. Many of the second-story windows have been covered with boards, but those that remain exposed are one-over-one units. The current wall finishes of the projecting second-story room vary and include vinyl siding, asphalt shingles, or stucco. The north masonry walls of 2028-2032 and 2036-2038 are common bond painted brick with segmented arches over the first-story doors and windows. The rear wall of 2034 is smooth stucco. The rear wall of 2026 is painted brick and lacks a second-story projection. Its flat elevation has a basement window, a boarded-up first-story door and transom on the west end, a first-story one-over-one window to the east, and two small one-over-one second-story windows. The rear wall of 2024 is smooth parged brick; it has no basement window; its first story has an east end steel entry door and a single west end one-over-one window; its second story has a three-sided vinyl-clad room projection with a single one-over-one center window. The rear wall parged masonry wall of 2022 extends further north than its neighbors; its first story has a single door on the east end and a steel bulkhead cellar door on the west end; its second-story has a three-sided vinyl clad projection with two one-over-one windows.

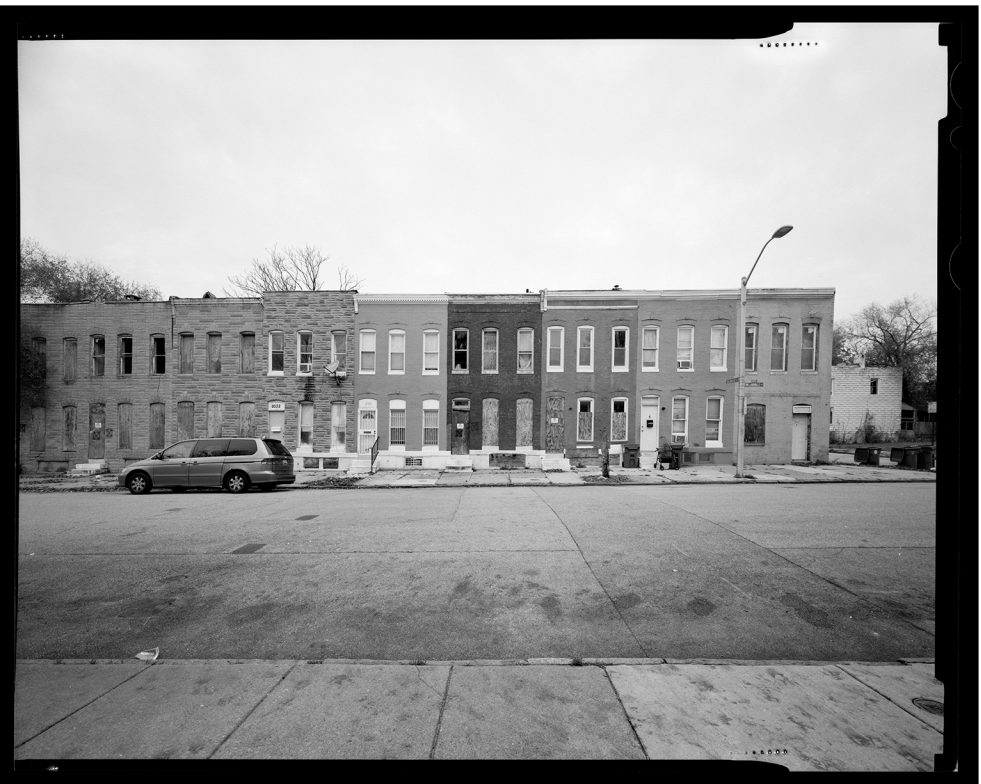
HABS No. MD-1442-3

| MD-1442-3 | View of façades of 2022-2036 West Lanvale Street, looking north. |

The eight rowhouses from 2024-2038 are side-hall-entry houses, each with a raised first story and marble steps, two basement level windows (some boarded over), and three bays on the first and second stories. The first story consists of a door with a transom in the western bay and two windows that match the height of the door. Stone belt courses are below the first-story windows on 2024-2034; segmental arches are above all openings in all nine houses; and stone windowsills are on the facades that retain their brick wall finish. What appears to be the original unpainted stretcher-bond red brick finish is only visible on the façade of 2028. The brick façades of 2022-2026 and 2030 have been painted, and the façades of 2032-2038 have been refaced with Formstone. All the rowhouses have flat roofs that slope from south to north, and all but 2032, 2036, and 2038 have simple projecting painted wood cornices with varying details.

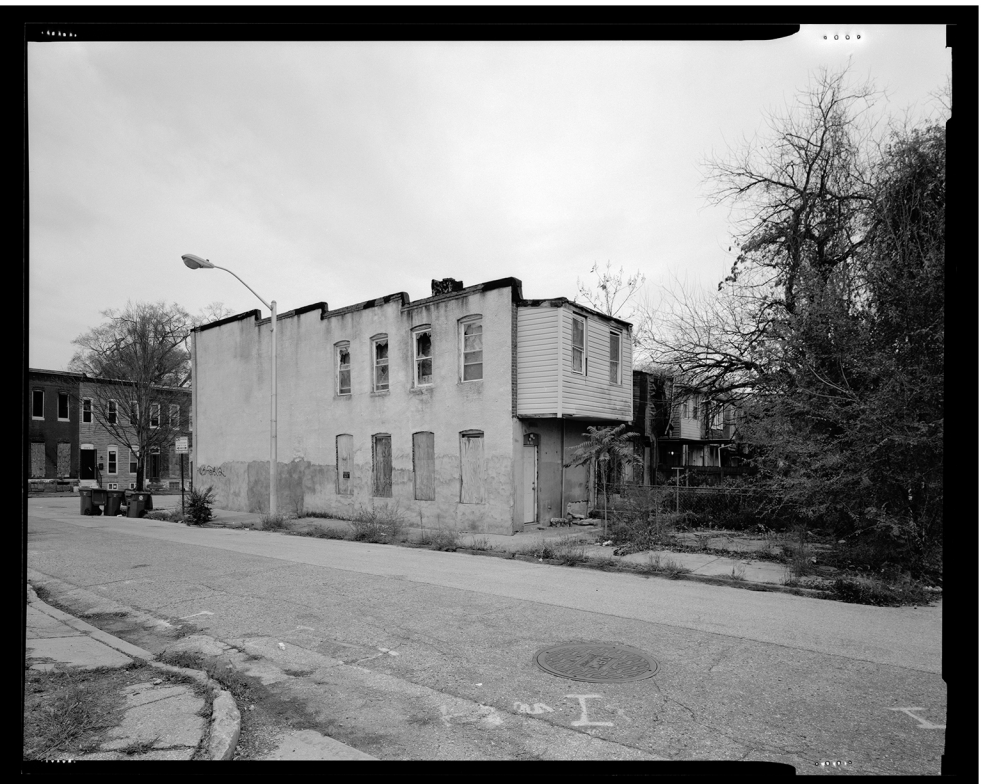
HABS No. MD-1442-5

| MD-1442-5 | Perspective view of side elevation of 2022 West Lanvale Street, looking southwest. |

door, and a single one-over-one window is west of the door. Architectural evidence, notably a continuous brick lintel above the first-story door and window and mismatched brick patterning that appears to be infill masonry, indicates that the façade originally had a storefront window. Archival evidence supports this finding, as 2022 is labeled as a store on the 1901 and 1914 Sanborn maps, but it is designated as a dwelling on the 1950 and later Sanborn maps.<sup>1</sup> Similar to the other houses in the block, 2022 has three second-story windows. All openings are capped by segmental arches. Its east elevation, facing North Brice Street, is finished in stucco and has a parapet that descends in four equal sections, with two first- and second-story windows in each of the two rear sections. (North Brice Street divides the 2000 block of West Lanvale Street.)

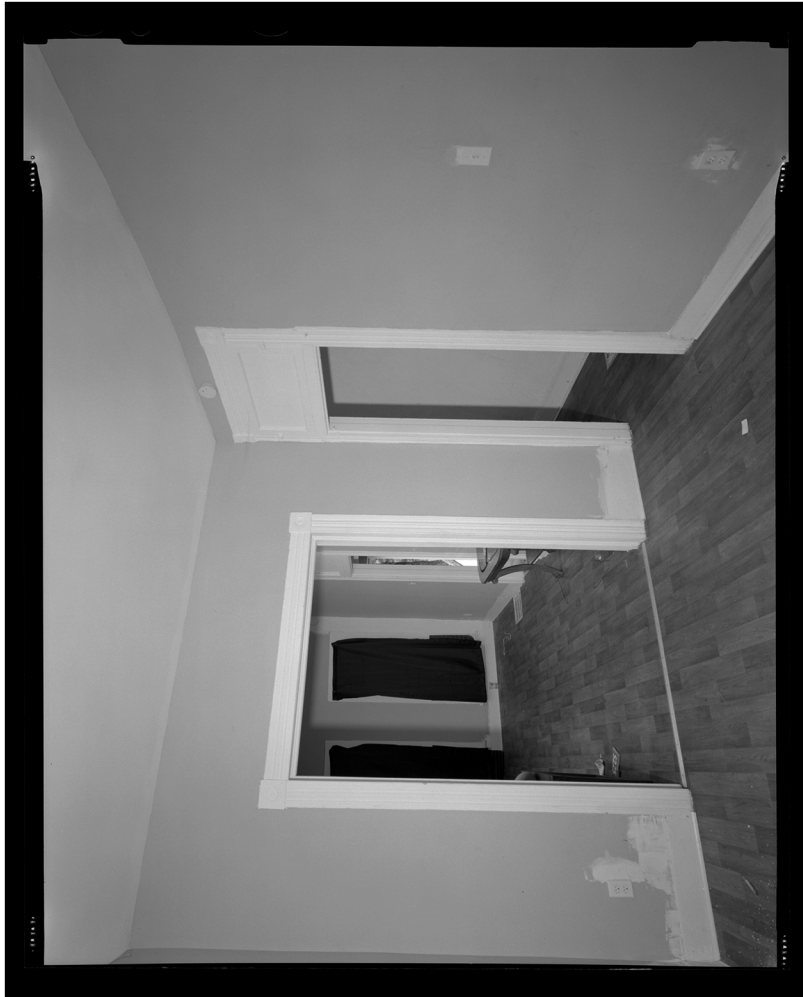
HABS No. MD-1442-6

| MD-1442-6 | Interior view of 2032 West Lanvale, looking southwest in first floor dining room. |

basements and have first stories-located approximately 24" above grade. A typical house in this row is entered through an exterior swing door leading to a small vestibule. After passing the vestibule door, one enters a narrow hallway leading to the wooden staircase to the second story. East of the corridor is the living room, which has archways located in the centers of the west and north walls. A covered-up fireplace is located near the center of the east wall in some of the units and two windows penetrate the south wall overlooking the street. In the center of the first-story plan is a windowless dining room that can be entered via the hallway from the west, the living room from the south, or the kitchen from the north through open archways of varying sizes. The north end of the dining room's west wall has a door that leads to stairs to the basement. The kitchen is north of the dining room. The south wall of the kitchen has an archway shared with the dining room and the west wall has a door accessing a small powder room with a sink and water closet that projects into the kitchen. The north kitchen wall has a window on the east end and a door to the backyard on the west end. The east kitchen wall has a counter with upper cabinets, a sink, and a space for a stove or refrigerator.

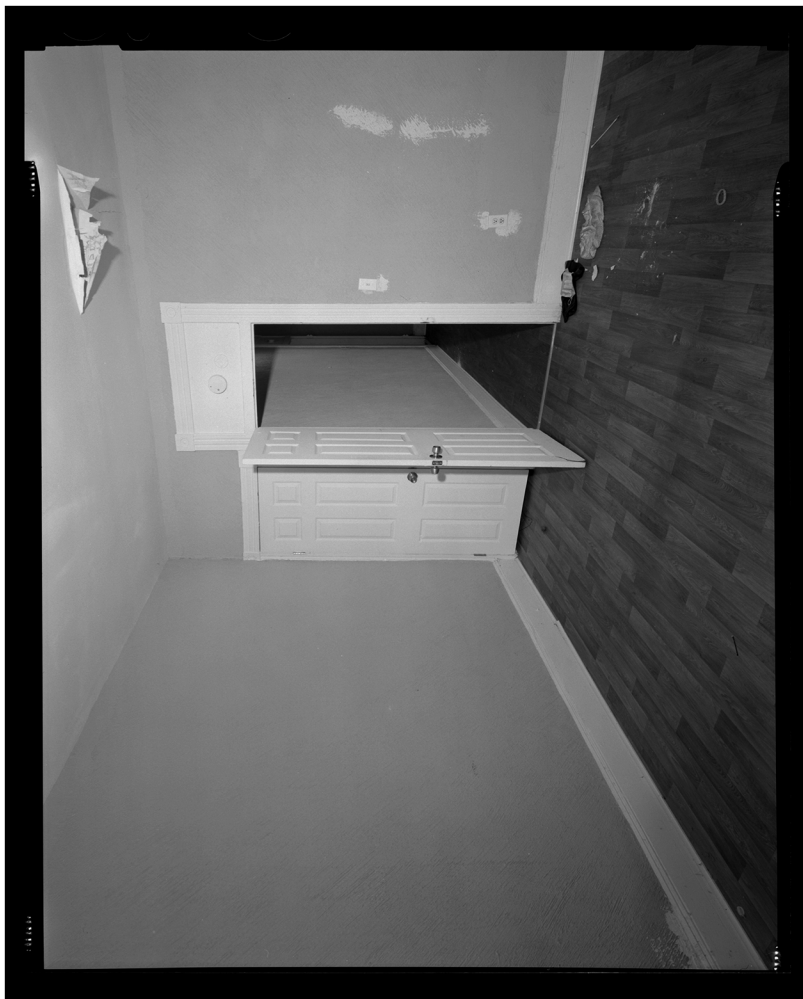
HABS No. MD-1442-7

| MD-1442-7 | Interior view of 2032 West Lanvale, looking north in second floor bedroom. |

The second story is accessed from the first-story hallway via a wooden staircase. The stairs exit onto a landing and second-story hallway that is illuminated by natural light coming from a square metal-framed pyramidal skylight with wire glass panes. The master bedroom, entered through a doorway in the south wall of the hallway, features three windows in the south bedroom wall, overlooking West Lanvale Street. A fireplace is near the center of the east wall and a closet with a swing door is located on the west end of the north wall next to the door entering from the hallway. East of the hallway near the center of the plan is a narrow rectangular windowless bedroom, which is afforded some daylight by a small portion of the hallway skylight that overlaps the room's west wall and extends a few inches into the narrow room's ceiling. A third bedroom is accessed through a door in the hallway directly opposite the staircase. The north wall of this bedroom has a large bay extending from the south wall that features two windows overlooking the backyard below. This bay is situated within the cantilevered second-story wood-framed projection that is visible on the exterior of the north wall. Also accessed from the hallway landing through a swing door is a full windowless bathroom with sink, toilet, and bathtub. The bathroom is situated between the second bedroom to the north and the narrow windowless room to the south. Original architectural details remaining in some of the rowhouses indicate that most of the interior doorways, archways, and windows were once framed with fluted wood moldings connected at right-angled corners with decorative corner blocks.
