## HISTORIC AMERICAN BUILDINGS SURVEY

### 812-816 NORTH BRICE STREET (ROWHOUSES) (MIDTOWN EDMONDSON HISTORIC DISTRICT)

HABS No. MD-1448

Location: 812-816 North Brice Street, Baltimore, Maryland

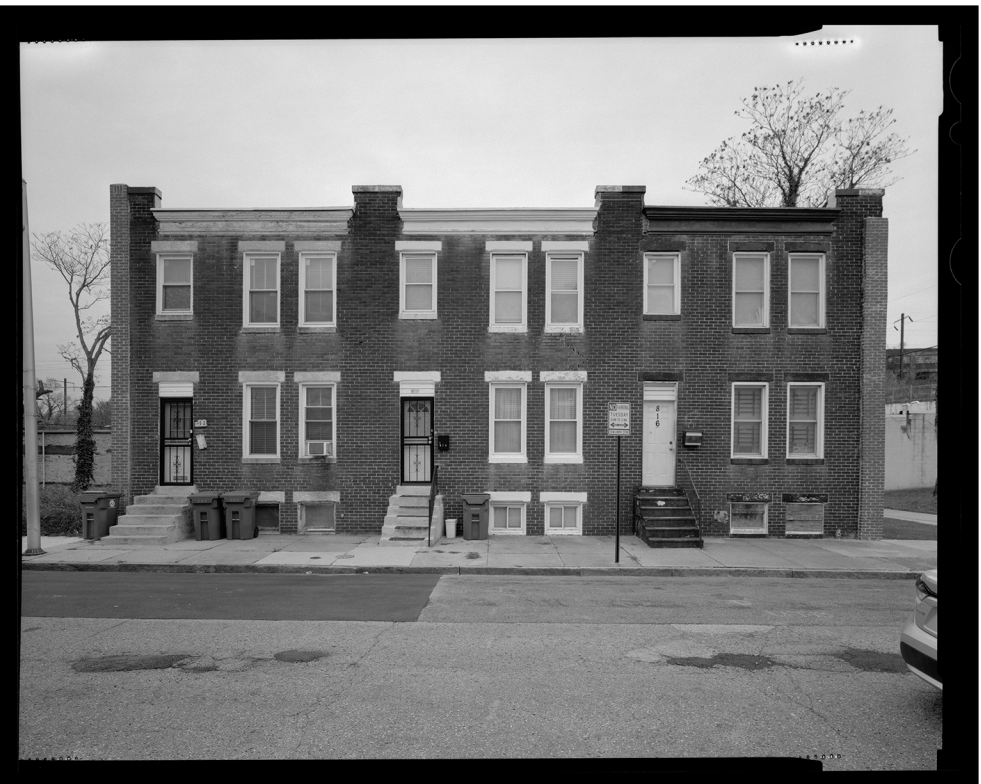
HABS No. MD-1448-1

Description: The rowhouses at 812-816 North Brice Street are located on the west side of the block located between West Lafayette Avenue to the north and West Lanvale Street to the south. They are two-story three-bay side-hall-entry Italianate rowhouses with identical façade configurations. Each house has two basement-level windows (some boarded over), and a raised first story accessed by painted concrete steps. The first story contains a door with a transom (infilled with aluminum siding) in the southern bay and two windows that match the height of the door. Painted stone lintels are above all openings, and each window has a painted stone sill. The façades retain their original red brick laid in a running bond pattern. The rowhouses have flat roofs that slope from east to west. Each of the three rowhouses has an identical simple projecting painted wood cornice separated from its neighboring dwelling by a brick parapet rising approximately 18" above the top of the cornice. These parapets are approximately 40" wide and are capped by a stone coping.

| MD-1448-1 | Elevation view of 812-816 North Brice Street, looking west. |

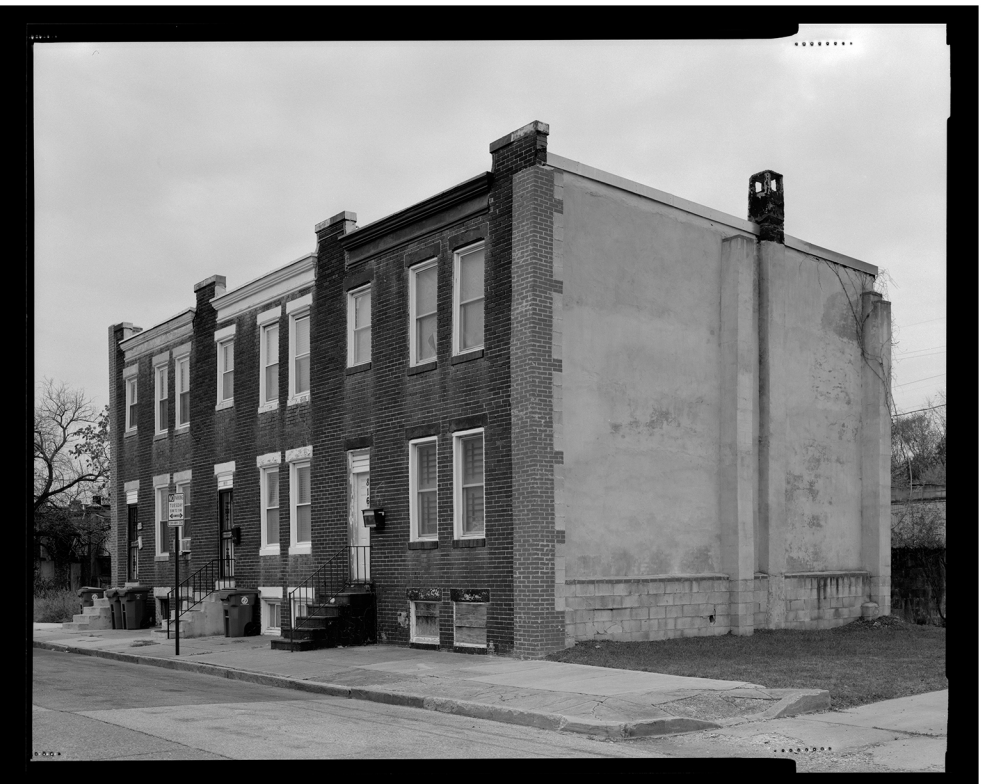
HABS No. MD-1448-2

| MD-1448-2 | Perspective view looking southwest. |

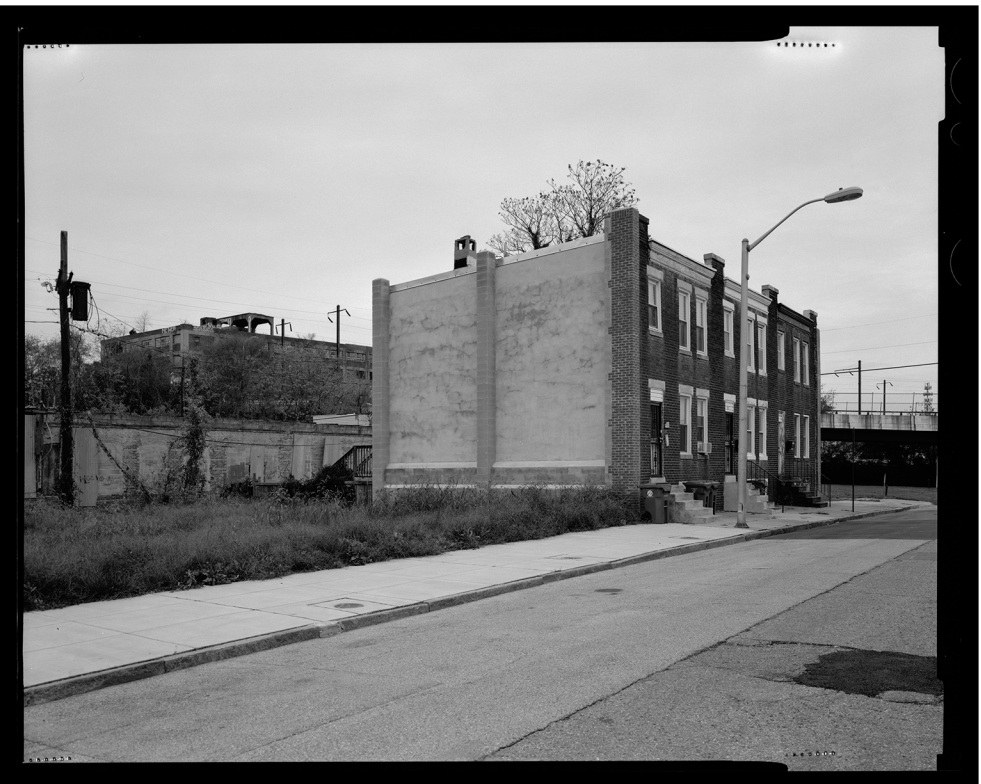
HABS No. MD-1448-3

| MD-1448-3 | Perspective view looking northwest, with the ACME Warehouse in the background. |

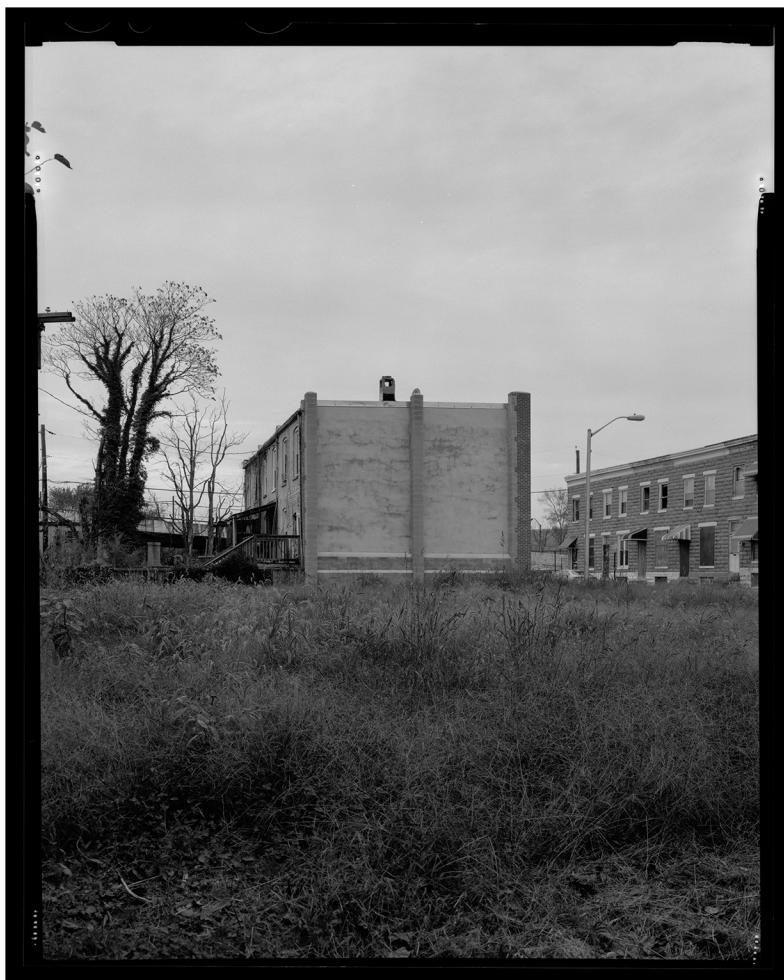
HABS No. MD-1448-4

The west (rear) elevation walls of 812 and 814 are painted brick laid in a running bond pattern. The rear wall of 816 is mostly painted smooth stucco with sections of painted brick. The masonry openings for all windows and doors on 812 and 814 are topped with segmental brick arches and the windows have brick sills. The arches and sills of 816 have been parged over with smooth painted stucco. The west elevation walls of 812 and 814 are topped by a simple brick cornice that is mostly obscured by a metal rain gutter; the top of the wall of 816 was completely obscured by vegetation at the time of the survey. The basement level of the 812-816 west elevations is only fully visible on the 812 unit. The basement level of 812 has two boarded-up masonry openings with segmental brick arches. The differing heights of the arched headers indicate that the northern opening once contained a basement window while the southern opening was a basement doorway.

| MD-1448-4 | Perspective view looking northeast. |

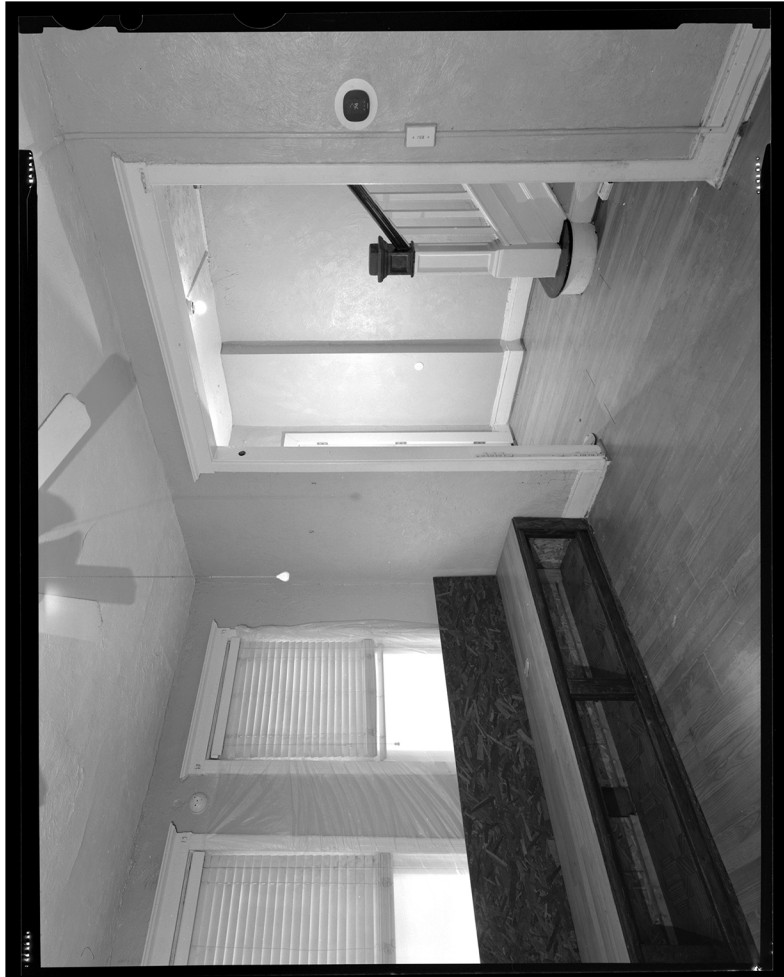
HABS No. MD-1448-5

| MD-1448-5 | Interior view of first floor of 814 North Brice Street, looking southeast. |

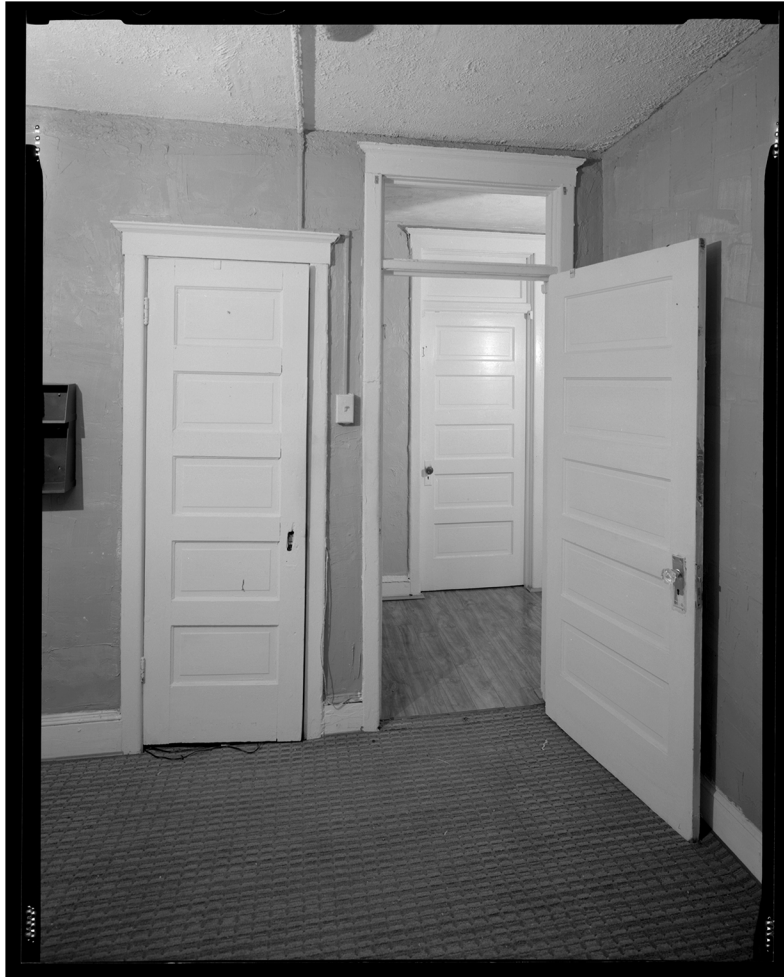
HABS No. MD-1448-6

| MD-1448-6 | Interior view of second floor of 814 North Brice Street, looking east. |
