# Pocono Mainline Track Cost Estimates

SCRANTON-NEW YORK INTERCITY PASSENGER RAIL ANALYSIS INFRASTRUCTURE ASSESSMENT  
TRACK COST ESTIMATES  
POCONO MAINLINE TRACK UPGRADES IMPROVEMENTS  
SUGGESTED PROGRAM

Amtrak engaged Jacobs Engineering Group, Inc, to assess the condition of existing structural assets on the Pocono Mainline and to determine the extent of physical improvements and their estimated costs necessary to upgrade the line for Amtrak intercity rail service. Pertinent assets include:

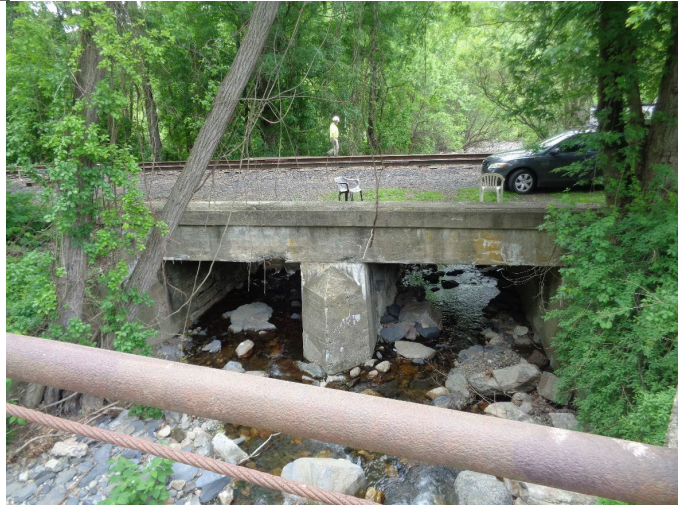
STRUCTURE	
LOCATION	MILEPOST 73.99
PLACEMENT	UNDERGRADE
TYPE	RAILTOP
SPANNING	CREEK
MATERIAL	CONCRETE
LENGTH	28 FT
WIDTH	
TRACKS	1
GENERAL CONDITION	SCOUR SETTLEMENT

Overall looking South

IMMEDIATE REPAIR NEEDS	
JOINT PRESSURE INJECTION	150 SF
STEEL RAILINGS	56 LF
RIP RAP/SCOUR PROTECTION	30 LF

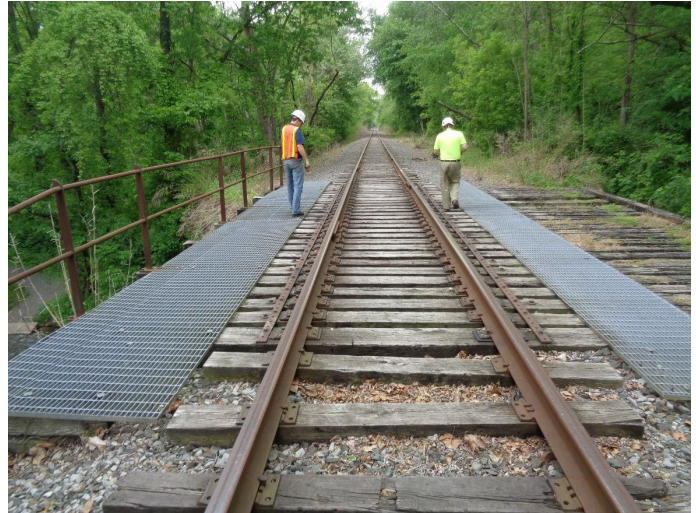
STRUCTURE	
LOCATION	MILEPOST 77.50
PLACEMENT	UNDERGRADE
TYPE	RAIL TOP BOX CULVERT
SPANNING	BROADHEAD CREEK
MATERIAL	STEEL DECK PLATE GIRDER
LENGTH	39 FT 6 IN
WIDTH	26 FT 8 IN
TRACKS	1 (FORMERLY 2)
GENERAL CONDITION	WINGWALLS CRACKED SE ABUTMENT CORNER IS CRACKED & SPALLED

OVERALL LOOKING WEST

IMMEDIATE REPAIR NEEDS	
STEEL RAILING	40 LF
REPOUR EAST ABUTMENT	24 CY

FUTURE (5-10 YRS) REPAIR NEEDS	
PAINT GIRDERS, CLEAR DEBRIS FROM BRIDGE SEATS, DECK REPLACEMENT (15 TIMBERS)

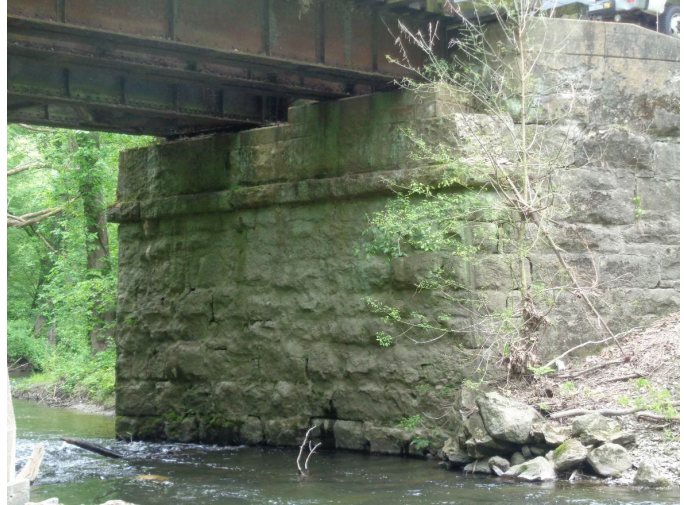
**EAST ABUTMENT, SOME CRACKS**

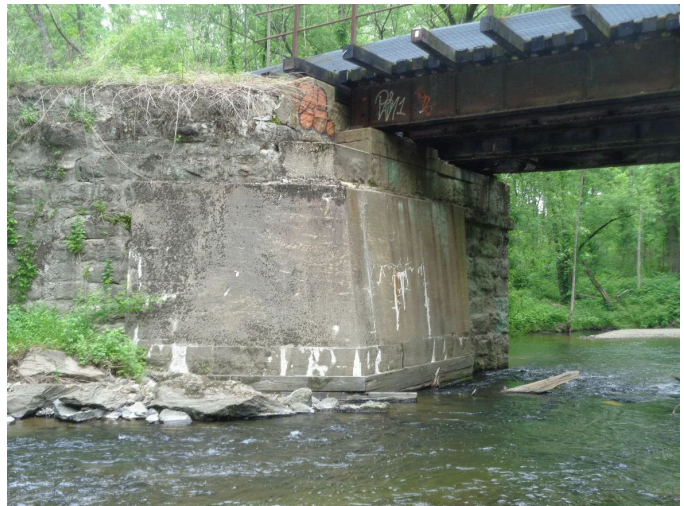
**OVERALL WEST ABUTMENT**

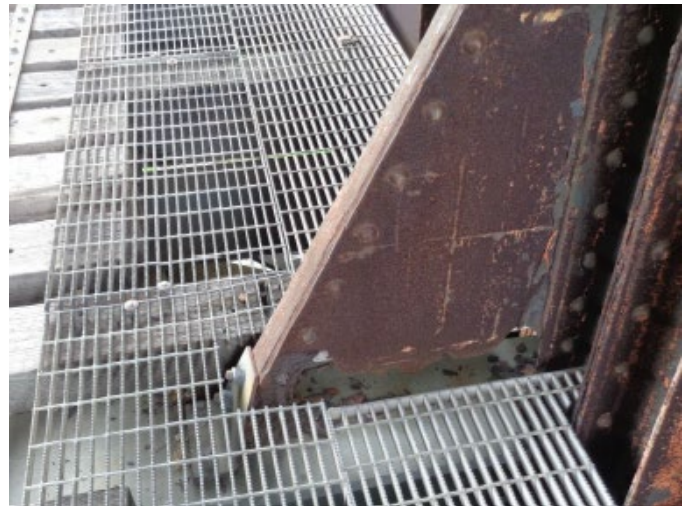
OVERALL GOOD CONDITION. RUSTING AND SCALING ON STEEL MEMBERS; INTERMEDIATE STIFFENERS HAVE SECTION LOSS; PAINT SYSTEM DETERIORATED; PIERS ON GOOD CONDITION; SECTION LOSS IN FLOOR BEAMS; STRINGERS, AND KNEE BRACES; STEEL REPAIRS TO FLOOR BEAMS AND STRINGERS

HOLES IN KNEE BRACES

PAINT GIRDERS; CONTINUE STEEL REPAIRS

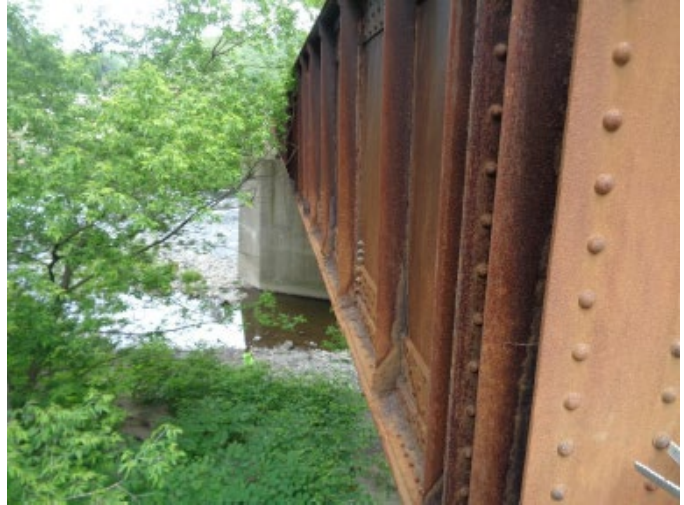
**INTERMEDIATE STIFFENER CORROSION  
NORTH GIRDER**

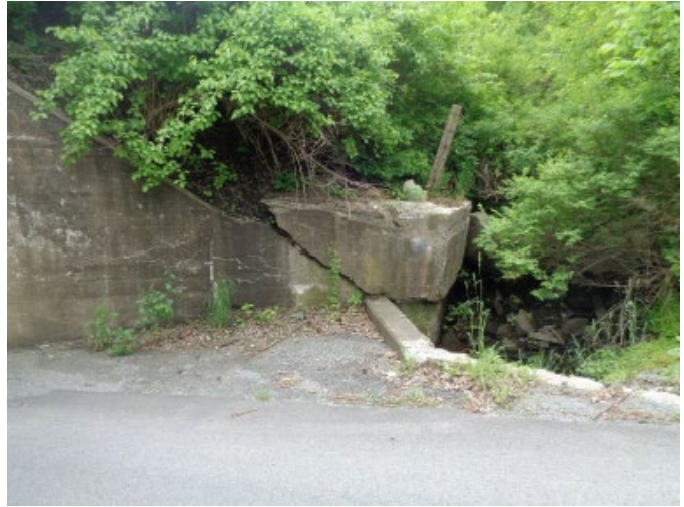
STRUCTURE	
LOCATION	MILEPOST 86.31
PLACEMENT	UNDERGRADE
TYPE	BOX SLAB
SPANNING	CHERRY LANE RD (SR1002)
MATERIAL	CONCRETE
LENGTH	61 FT FROM ROAD
WIDTH	17 FT 6 IN FROM ROAD
CLEARANCE	10 FT 8 IN
TRACKS	1
<b>GENERAL CONDITION</b> OVERALL GOOD CONDITION MINOR SPALLING SE WINGWALL CRACKED & DISPLACED BUILT IN 1911

**SE WINGWALL CRACKED & DISPLACED**

IMMEDIATE REPAIR NEEDS	
STEEL RAILING	36 LF
APPROACH CLEARANCE SIGNS	2 EA

FUTURE (5-10 YRS) REPAIR NEEDS	
SPALLING REPAIRS

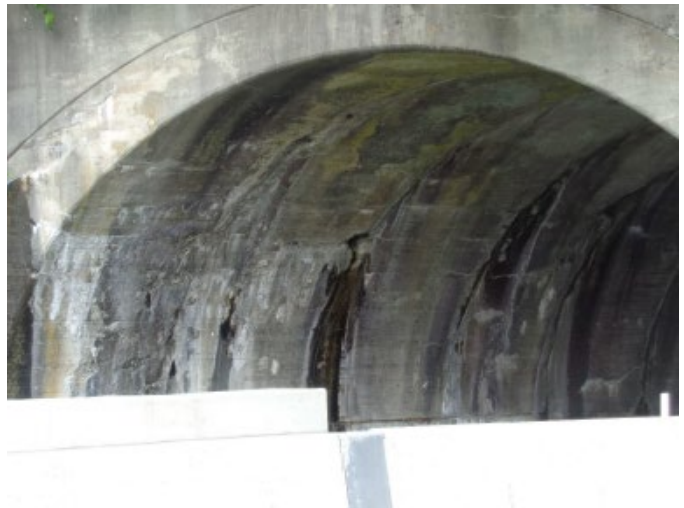
LEAKY JOINT THROUGH RIVER TUBE  
SPALLS THROUGHOUT RIVER TUBE

TYPICAL JOINT LEAKAGE

SPALLING REPAIRS (APPROXIMATELY 800 SF)  
JOINT REPAIR (APPROXIMATELY 1700 LF)

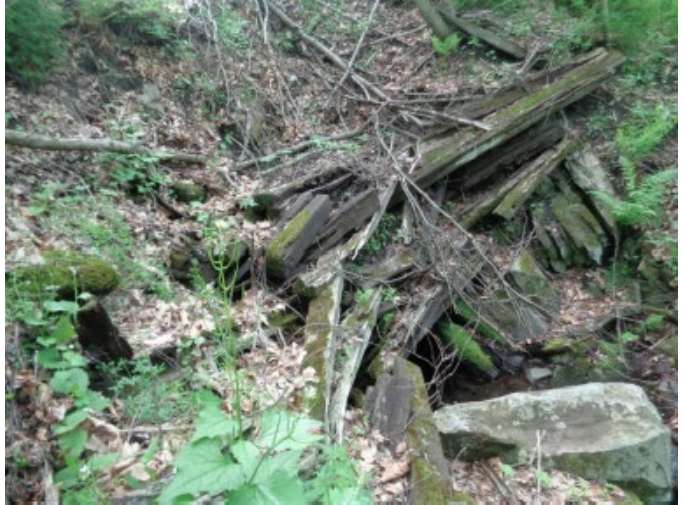
STRUCTURE	
LOCATION	MILEPOST 90.95
PLACEMENT	UNDERGRADE
TYPE	STONE BOX CULVERT
SPANNING	STREAM
MATERIAL	MASONRY
LENGTH	3 FT X 5 FT STONE BOX
WIDTH	
TRACKS	1
<b>GENERAL CONDITION</b> DEBRIS AND SILT SOUTH HEADWALL NORTH HEADWALL COLLAPSED

OVERALL LOOKING SOUTH

IMMEDIATE REPAIR NEEDS	
CLEAR DEBRIS,. VEGETATION	50 SF
REBUILD NORTH HEADWALL	7.5 CY

FUTURE (5-10 YRS) REPAIR NEEDS
SLIP LINE EXISTING BARRELL

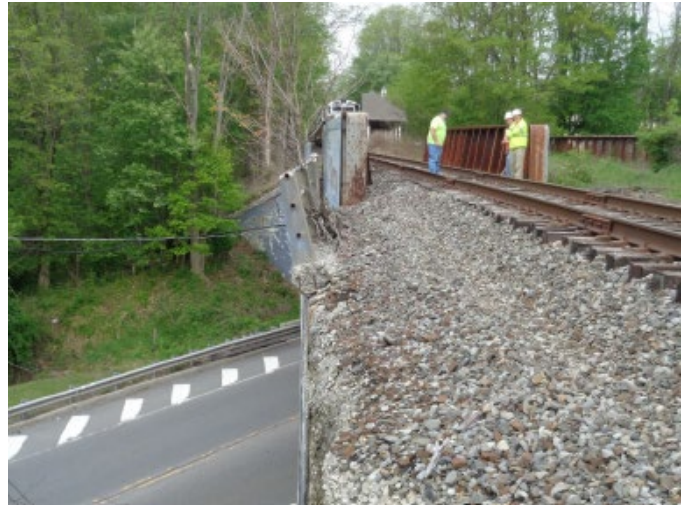
RAILING ON SE CORNER DETERIORATED /  
PARTLY COLLAPSED  
REBUILD SE WINGWALL CAP  
BRIDGE SEAT CAP DETERIORATED ON EAST  
ABUTMENT

RAILING DETERIORATED ON SE SIDE

SURFACE SPALLING	200 SF
STEEL RAILING	40 LF
CONCRETE WINGWALL CAP	1.5 CY
CONCRETE BRIDGE SEAT	2.5 CY

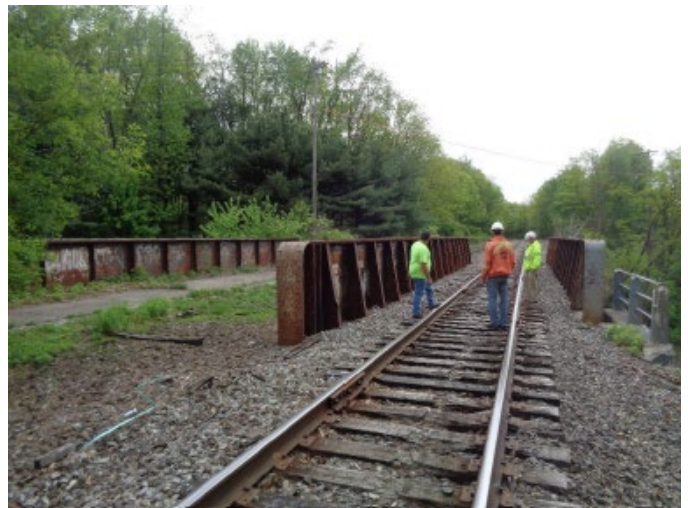
LOOKING NE; DAMAGED MEMBER

PAINT STEEL GIRDERS

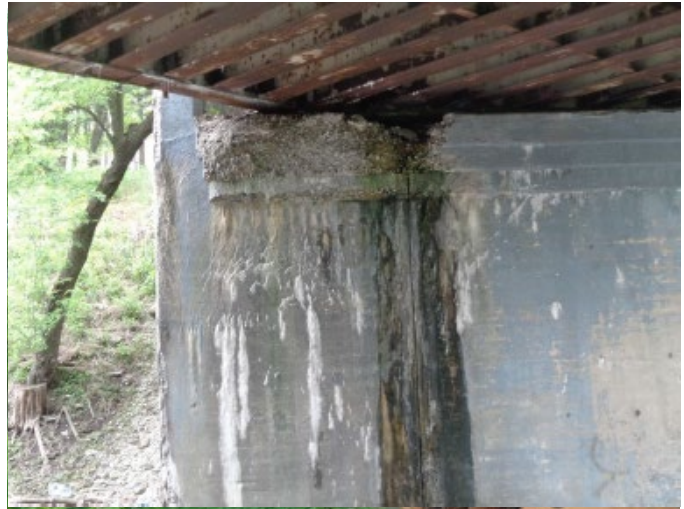
DETERIORATED BRIDGE SEAT ON EAST ABUTMENT

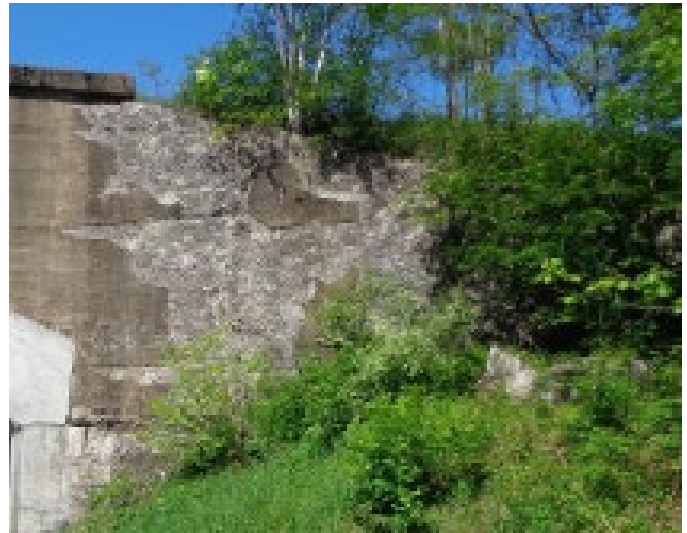
STRUCTURE	
LOCATION	MILEPOST 107.05
PLACEMENT	UNDERGRADE
TYPE	47 FT CONCRETE ARCH
SPANNING	STREAM
MATERIAL	CONCRETE
LENGTH	47 FT ARCH
WIDTH	
CLEARANCE	
TRACKS	1
GENERAL CONDITION SUBSTANTIAL SPALL THROUGHOUT WINGWALLS

WINGWALL SPALL DETAIL LOOKING NORTH

FUTURE (5-10 YRS) REPAIR NEEDS
.SURFACE SPALL REPAIR (APPROXIMATELY 300 SF)

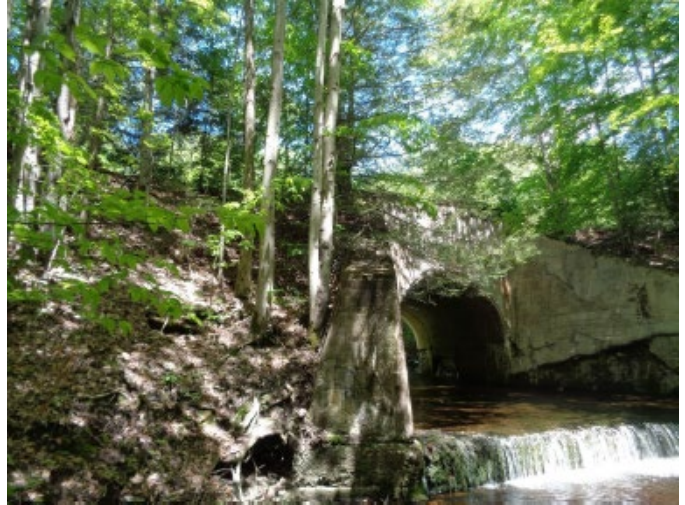
LARGE CRACK IN NORTHEAST WINGWALL  
NORTH SIDE BADLY SPALLED, SCoured UP  
TO 5 FT ABOVE WATER LINE  
GOOD FLOW

OVERALL LOOKING SOUTHEAST

IMMEDIATE REPAIR NEEDS	
CLEAR DEBRIS, . VEGETATION	120 SF
STEEL RAILING	10 LF
SCOUR INSPECTION	YES
POUR NEW BENCH WALLS (2)	4 CY
REPAIR NORTHEAST WINGWALL	5.5 CY

FUTURE (5-10 YRS) REPAIR NEEDS	
SCOUR INSPECTION

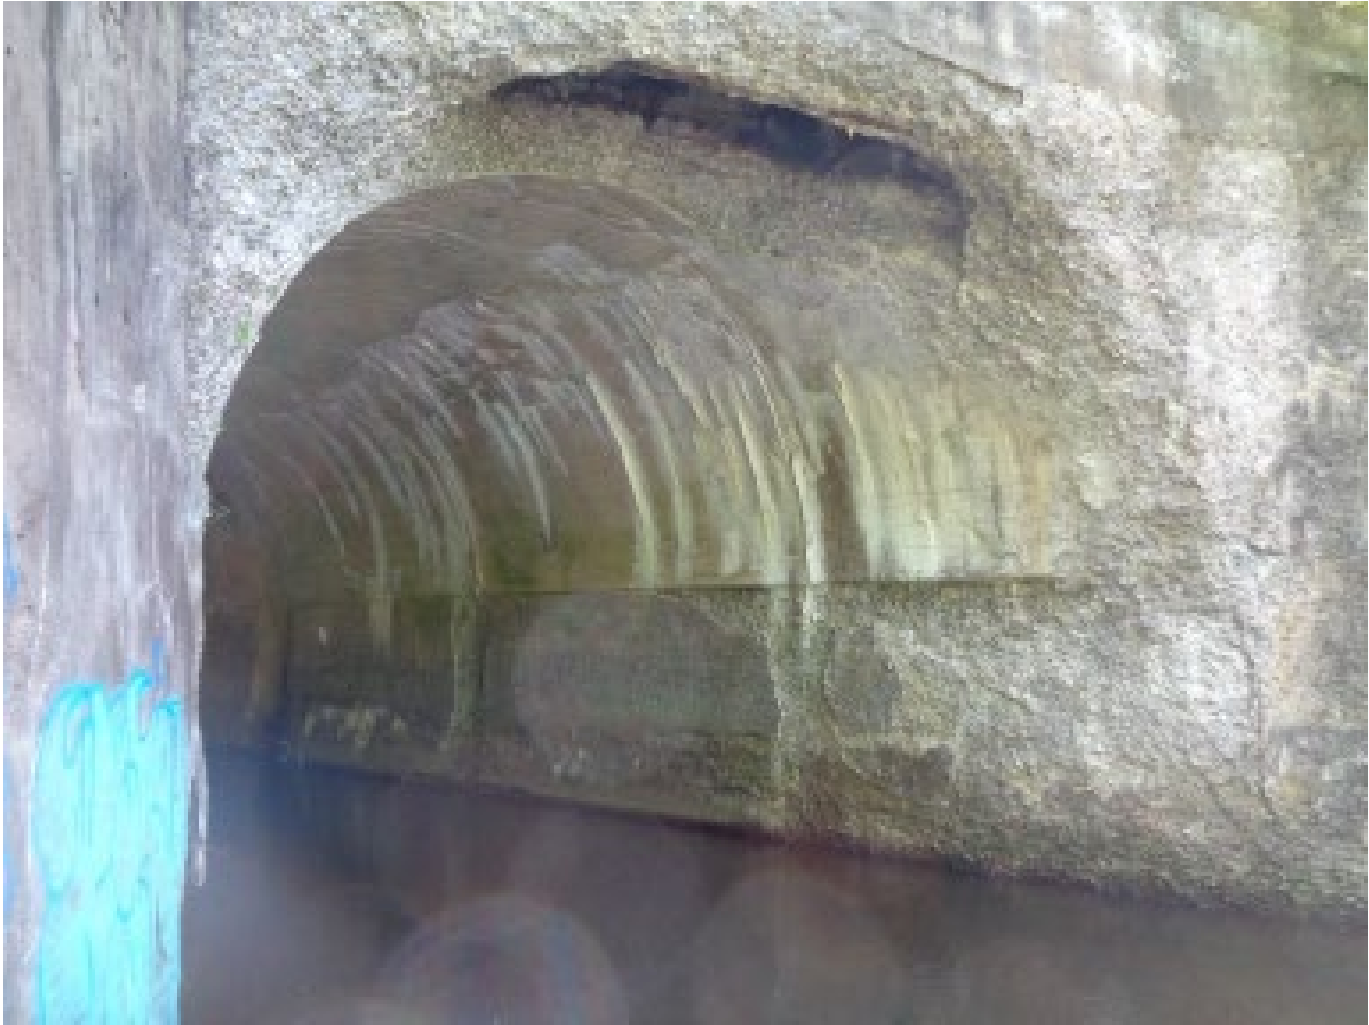
LARGE DEEP SPALL ON NORTH HEADWALL

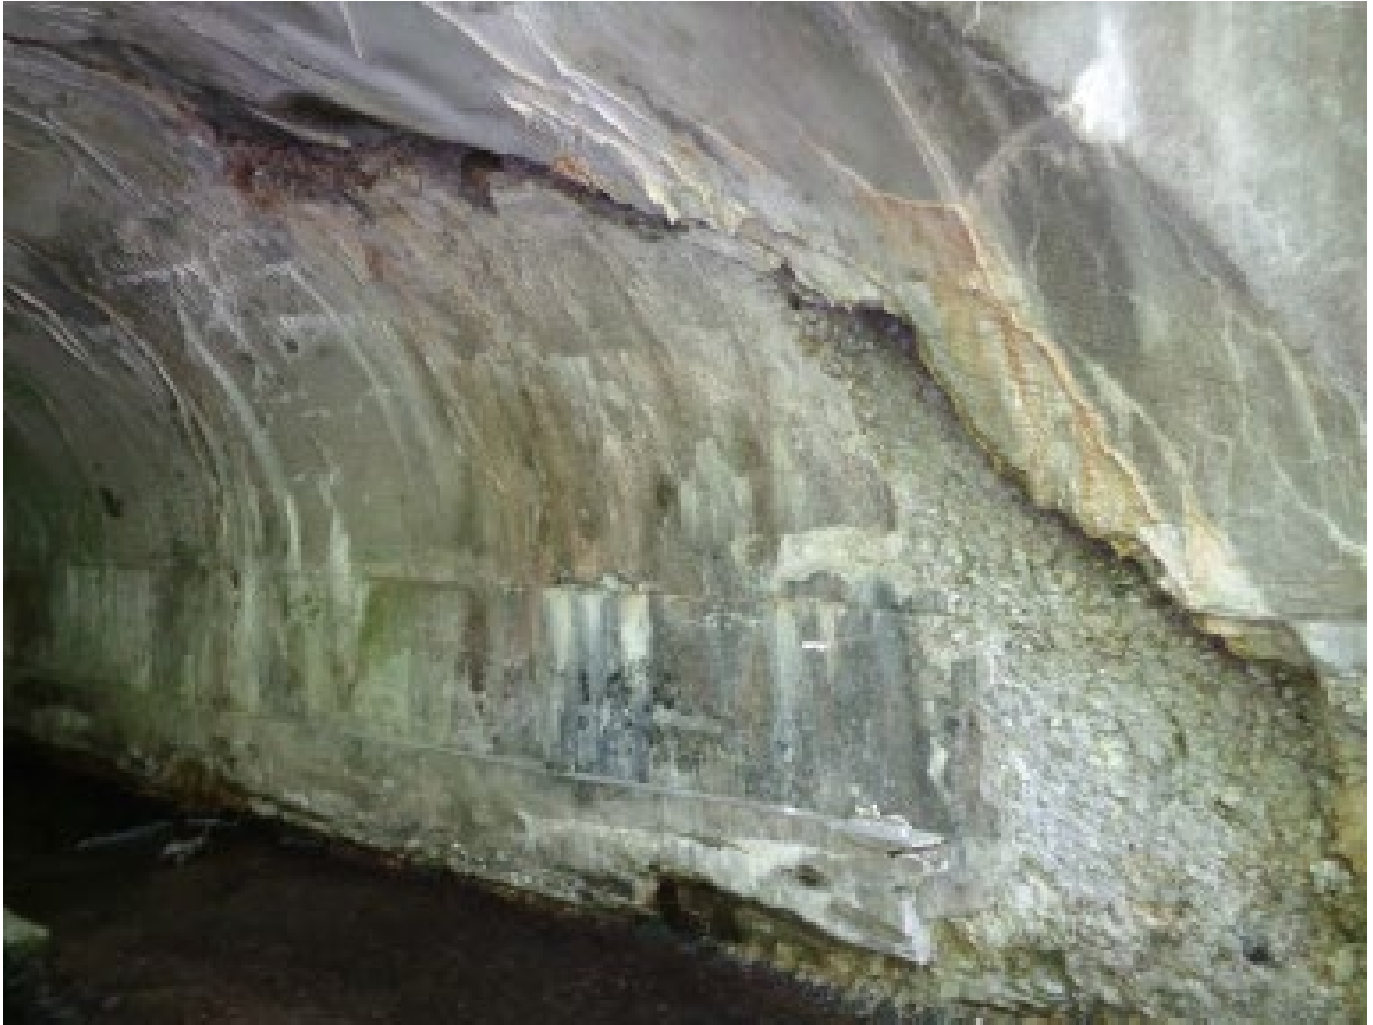
SPALLING IN WEST CULVERT WALL

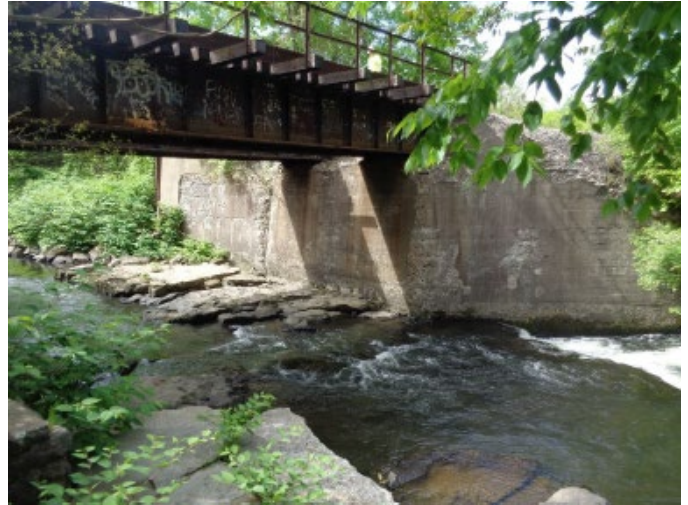
WEST ABUTMENT SPALLING

PAINT GIRDERS  
SCOUR INSPECTION

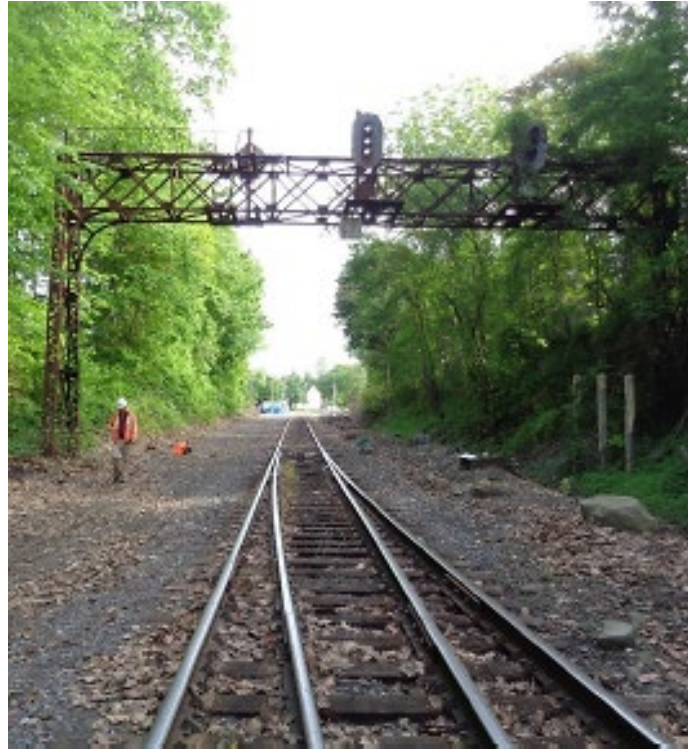
TYPICAL DL&W SIGNAL BRIDGE

IMMEDIATE REPAIR NEEDS	
REMOVE DEFUNCT SIGNALS	87 EA

FUTURE (5-10 YRS) REPAIR NEEDS	
INSPECT SIGNAL BRIDGES
